Device limitations for STM8AFx2xx automotive MCUs featuring up to 128 Kbytes of Flash program memory

Silicon identification

This errata sheet applies to the STMicroelectronics STM8AF526x/8x/Ax and STM8AF6269/8x/Ax devices. The full list of part numbers is given in [Table 2](#).

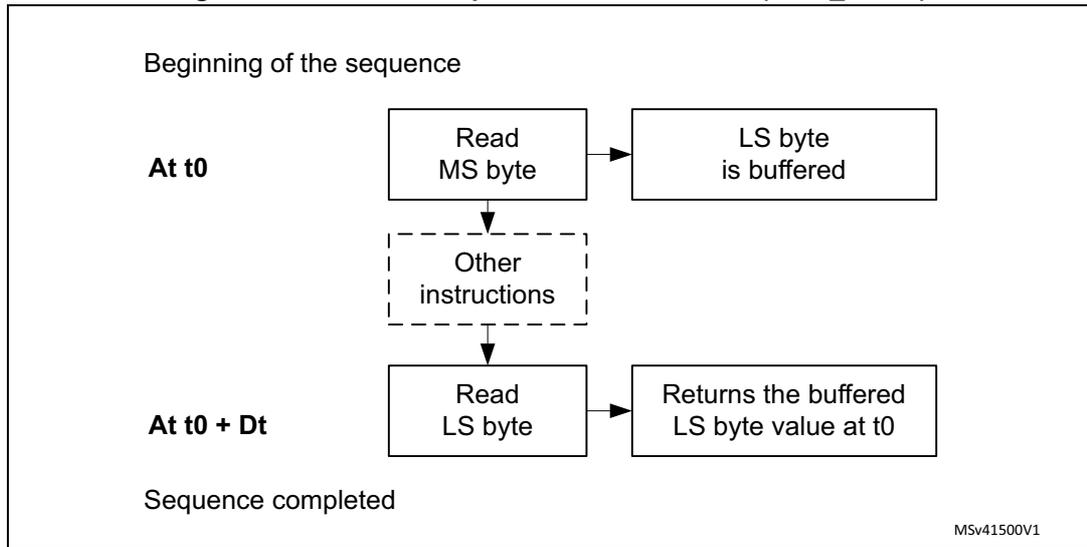
Figure 1. 16-bit read sequence for the counter (TIMx_CNTR)

2.3 Timer peripheral limitations**2.3.1 Corruption of read sequence for the 16-bit counter registers****Description**

An 8-bit buffer is implemented for reading the 16-bit counter registers. Software must read the MS byte first, after which the LS byte value is buffered automatically (see [Figure 1](#)). This buffered value remains unchanged until the 16-bit read sequence is completed.

When any multi-cycle instruction precedes the read of the LSB, the content of the buffer is lost and the second read returns the immediate content of the counter directly.

Do not use multi-cycle instructions before reading the LSB.

No fix is planned for this limitation.
