Chip Errata for the i.MX 6Solo/6DualLite

This document details the silicon errata known at the time of publication for the i.MX 6Solo/6DualLite multimedia applications processors.

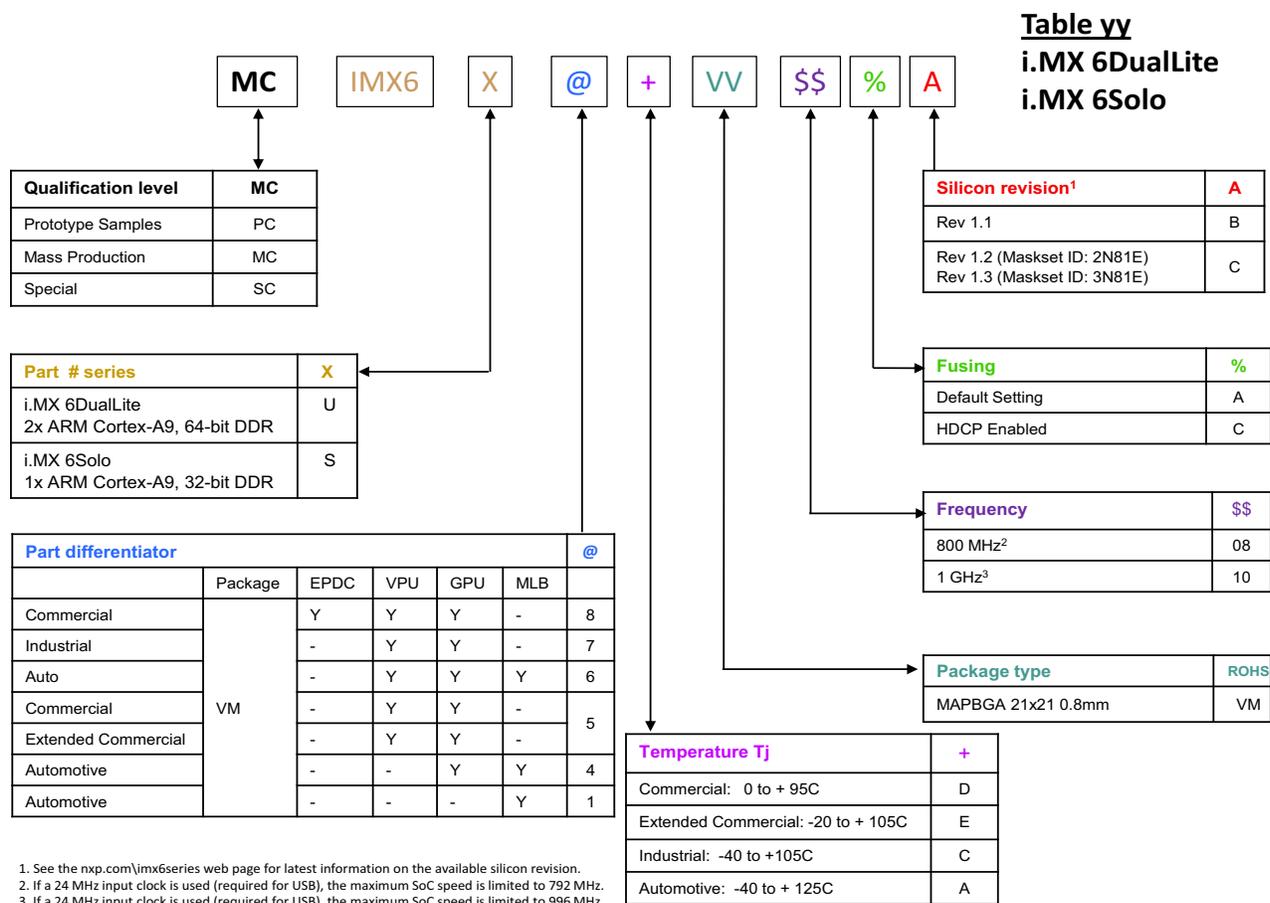
Figure 1. Revision Level to Part Marking Cross-Reference

Figure 1 provides a cross-reference to match the revision code to the revision level marked on the device.

| Rev. Number | Date | Substantive Changes |
|---|---|---|
| Rev. 3 | 11/2013 | <ul style="list-style-type: none"> • Updated Figure 1, "Revision Level to Part Marking Cross-Reference." • Added the following: ERR007005, ERR007006, ERR007007, ERR007008, ERR007117, ERR007122, ERR007220, ERR007265, ERR007266 • Updated the following: ERR003778, ERR004512, ERR005313, ERR005991 |

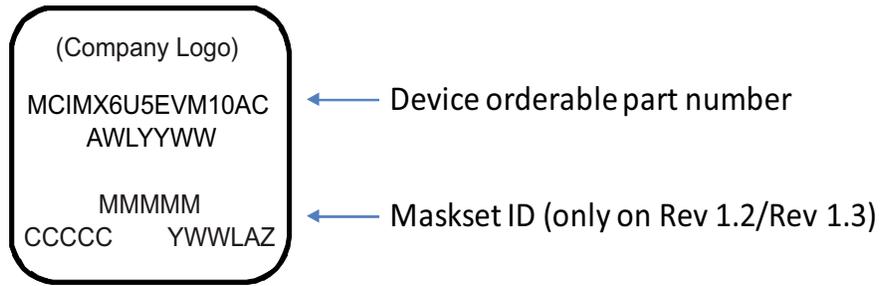
Figure 2. Example Part Marking for Revision 1.2/1.3 Devices

Figure 2 shows an example part marking for Revision 1.2/1.3 devices.
